# **INDOOR AIR QUALITY ASSESSMENT**

**Massachusetts Department of Social Services  
215 Hamilton Street  
Leominster, Massachusetts**

Prepared by:  
Massachusetts Department of Public Health  
Bureau of Environmental Health Assessment  
Emergency Response/Indoor Air Quality Program  
September 2003

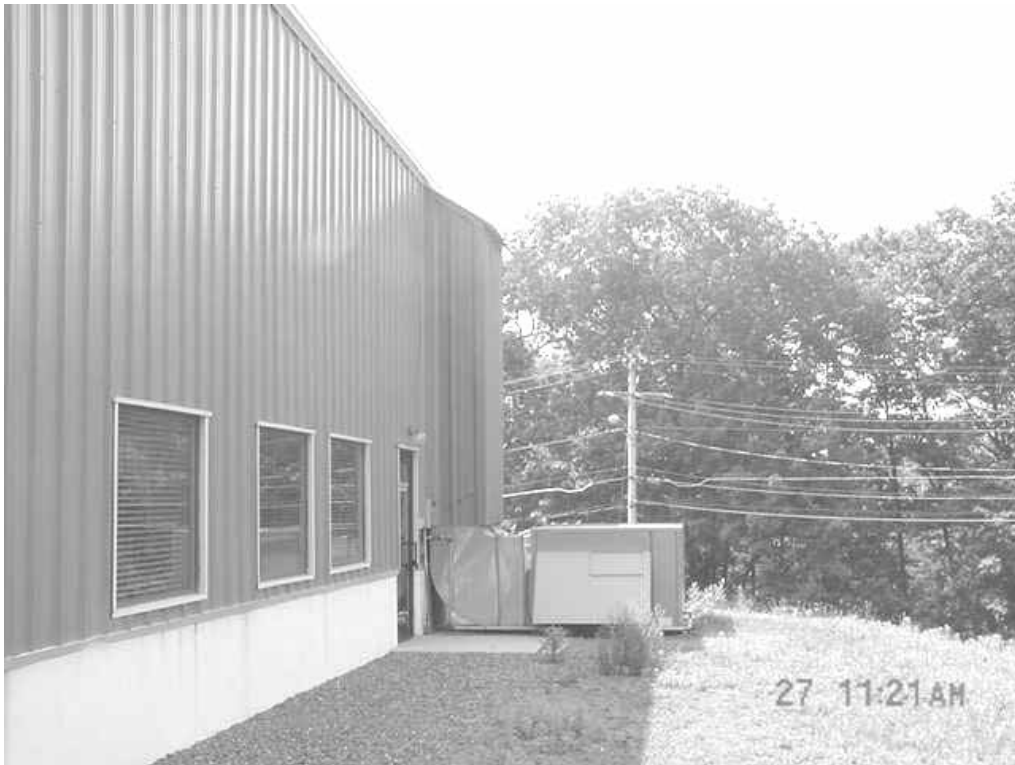
**Picture 1**

Fresh, heated air is supplied by four air-handling units (AHUs) located at ground level on the exterior of the building (see Picture 1). Ventilation is delivered to occupied areas via ceiling-mounted air diffusers connected to ductwork (see Picture 2).

**Typical AHU for DSS Office Space**

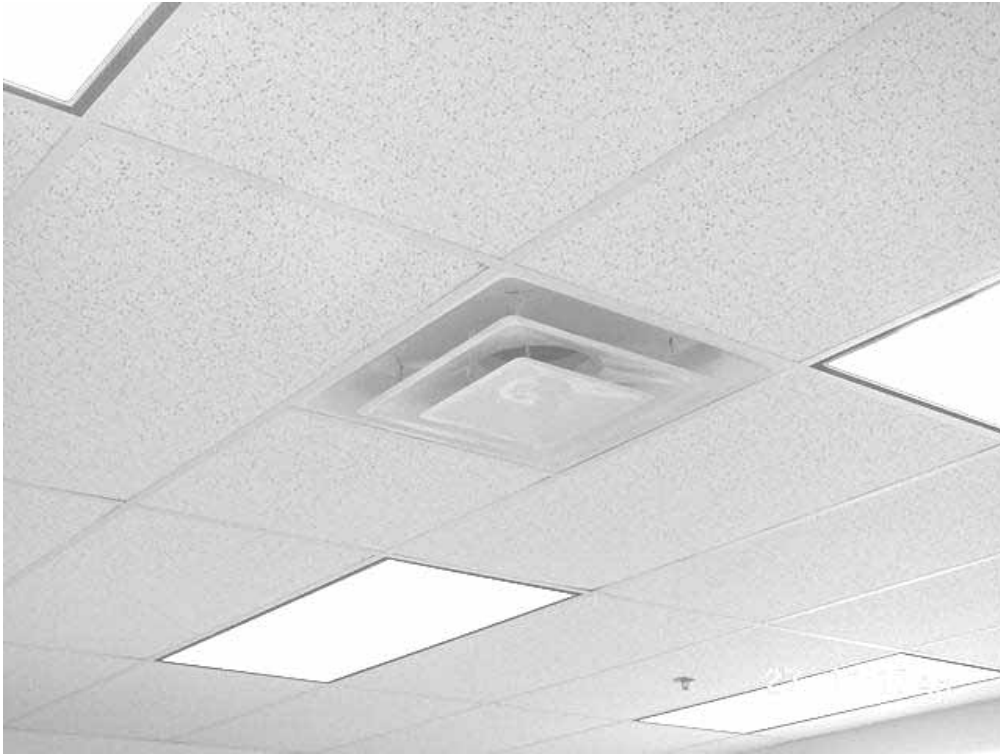
**Picture 2**

**Ceiling-Mounted Air Diffuser**

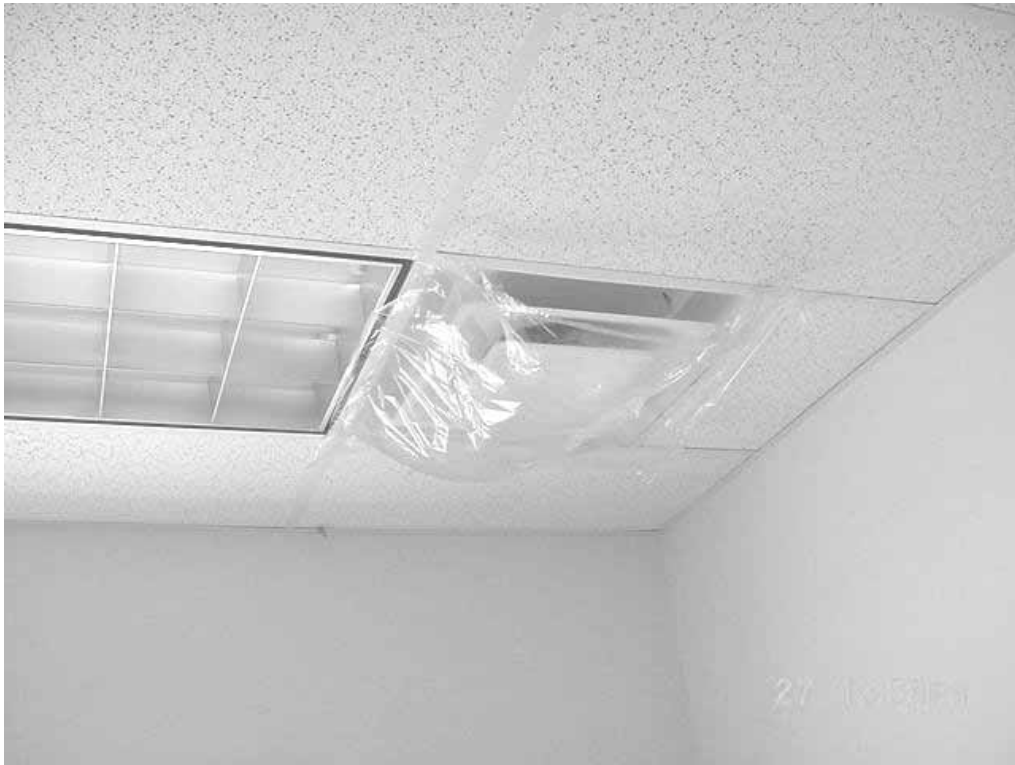
**Picture 3**

The vent in Picture 3 was covered with plastic, presumably to minimize drafts. However, this alteration of the system can throw the system off-balance and create uneven heating/cooling conditions in other areas adjacent to the blocked diffuser.

**Fresh Air Supply Diffuser Covered With Plastic**

9. Remove blockages from air diffusers (i.e. plastic) to facilitate airflow. Consider reconfiguring office space or replacing air diffuser with an alternative design to improve occupant comfort.

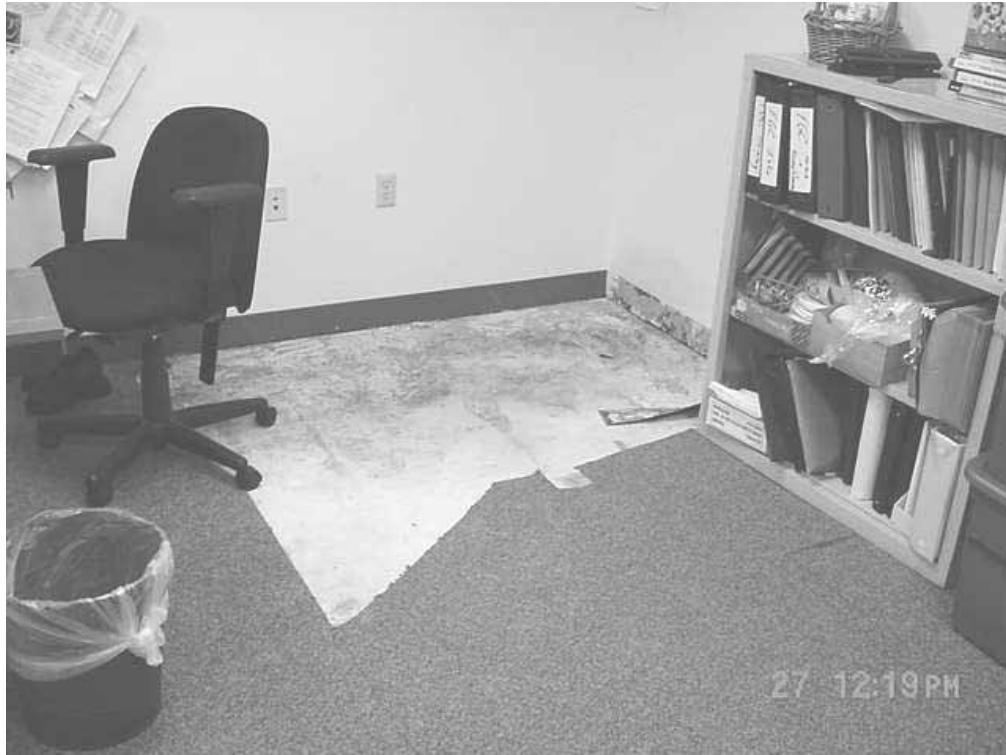
**Picture 4**

In order for building materials to support mold growth, a source of water exposure is necessary. Identification and elimination of water moistening building materials is necessary to control mold growth. GW with increased moisture content over normal concentrations may indicate the possible presence of mold. Identification of the location of GW with increased moisture levels can also provide clues concerning the source of mold growth. In an effort to ascertain moisture content of GW, measurements were taken in areas directly impacted by water damage as well as a number of areas that appeared not to have been effected for comparison (Table 1). As previously mentioned, water content of GW was measured with a Delmhorst, BD-2000 Model, Moisture Detector with a Delmhorst Standard Probe. The probe was inserted into the surface of GW at various heights. The Delmhorst probe is equipped with three lights as visual aids to determine moisture level. Readings which activate the green light indicate a sufficiently dry moisture level (0 - 0.5%), those that activate the yellow light indicate borderline conditions (0.5 – 1.0%) and those that activate the red light indicate elevated moisture content (> 1%). No elevated moisture measurements were recorded. These results indicate that the building materials were not moistened at the time of this assessment and that microbial growth would be limited due to a lack of water. However, a dry dark substance, which appeared to be mold, was observed along the surface of GW where rubber coving was removed (see Picture 4).

**Occupied Area Where Water Damage Occurred, Note Dark Staining on Floor and Base of Wall**

1. Continue to implement recommendations provided by the MDOS (MDOS, 2002).
2. Remove water damaged carpeting and rubber baseboard coving in the general vicinity of water leakage and examine for fungal growth. Vacuum dry surface of floor and along base of GW with a HEPA filter equipped vacuum cleaner. Disinfect non-porous surfaces with clean with an appropriate microbiological agent.

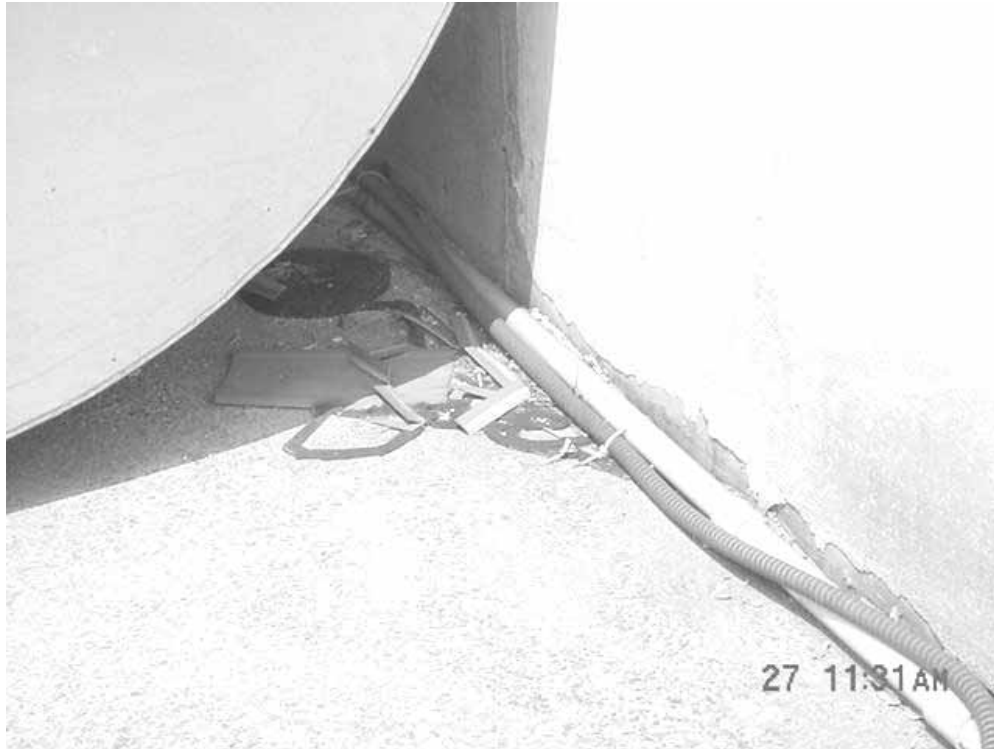
**Picture 5**

During the second week of June 2003, the building experienced water damage due to water infiltration along the southeast wall of the building. Carpeting and rubber baseboard coving in this area were removed, exposing a black substance on the walls interior that occupants believed to be microbial growth (see Picture 4). The most likely source of infiltration appears to be along the tarmac/exterior wall junction and around HVAC ductwork that traverses the exterior wall in this area. Rainwater appears to pool on the ground at the base of the building in this area as evidenced by water damage and moss growth at the base of the exterior wall (see Pictures 5 & 6). Moss growth is another indication of chronic moisture exposure from rainwater. Moss growth also holds moisture against brickwork. Excessive exposure to water can result in damage to building materials over time. During winter weather, the freezing and thawing of moisture can accelerate deterioration of cement, brick/mortar and other building materials. DSS officials reported that the building management had made repairs to the exterior of the

**Water Damaged Exterior Wall Material and Moss Growth along Southeast Side of Building Where Water Infiltration Occurred**

5. Continue to examine methods to eliminate water penetration into the building. Consider consulting a building engineer/building envelope specialist about possible

- options to eliminate water penetration. Explore options for providing a water/vapor barrier between exterior walls and interior space. Work with building envelope specialists to make repairs/improve flashing to prevent further leaks.

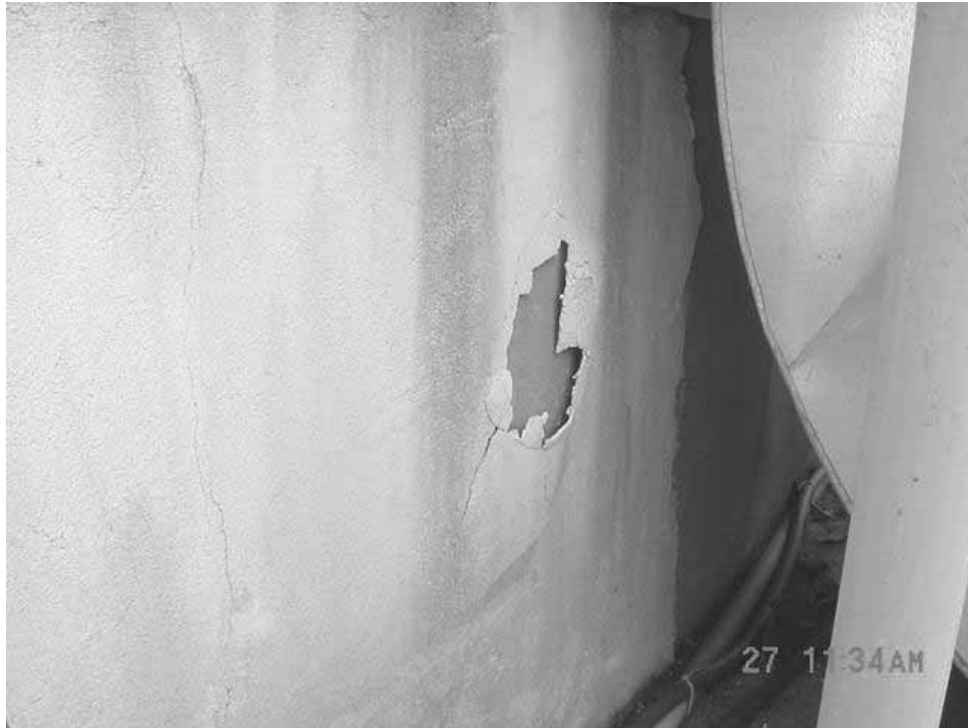
**Picture 6**

**Water Damaged Exterior Wall Material and Moss Growth along Southeast Side of Building Where Water Infiltration Occurred**

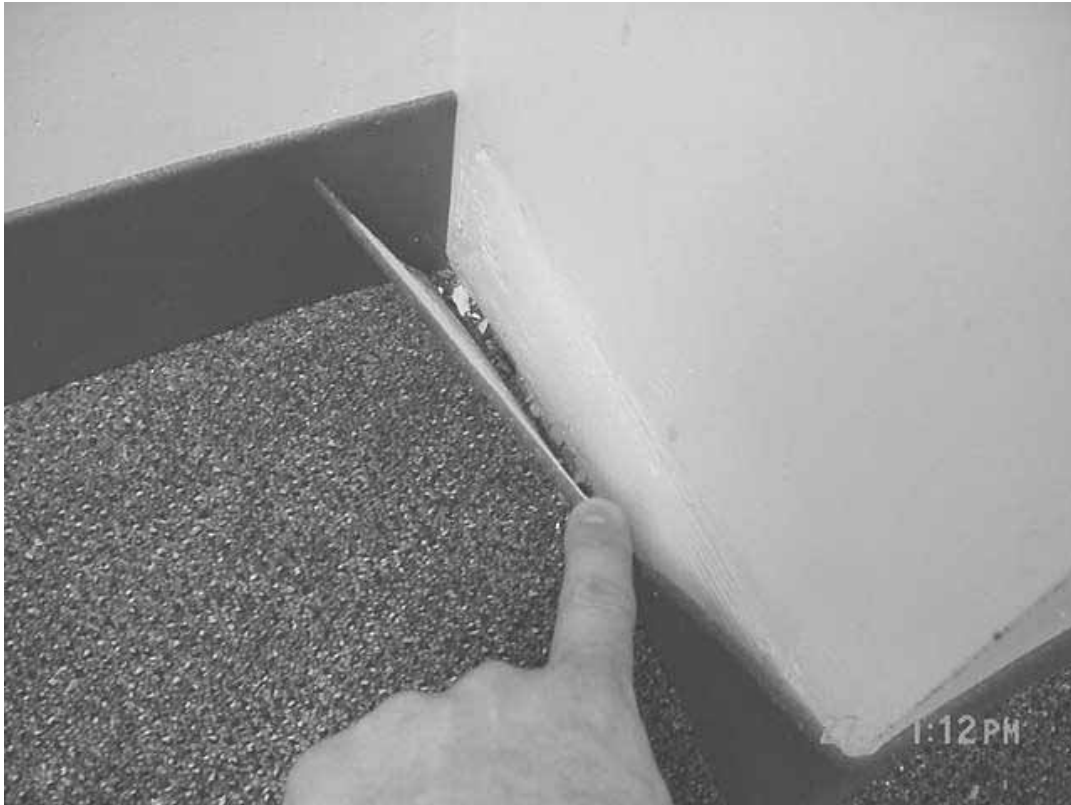
**Picture 7**

to observe conditions in the ceiling plenum. No obvious signs of water damage, mold growth and/or associated odors were detected (see Picture 7). The most likely source of water leakage in this area is flashing around ductwork that enters the building directly outside of Mr. Perreault's office (see Picture 8).

**Rubber Coving Removed in Mr. Perrault's Office, No Signs of Water Damage/Mold Growth**

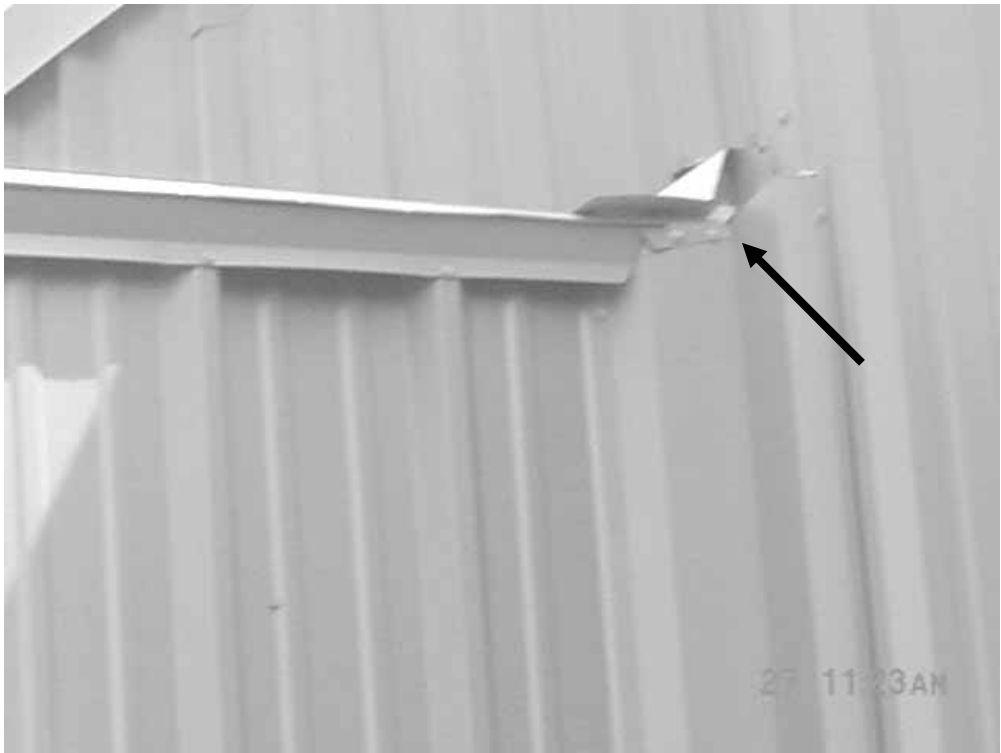
**Picture 8**

**Aluminum Flashing Around Ductwork**

13. Work with a roofing contractor to identify and repair leaks. Replace any water-stained ceiling tiles and building materials. Examine the area above and around these areas for mold growth. Disinfect areas of water leaks with an appropriate antimicrobial.

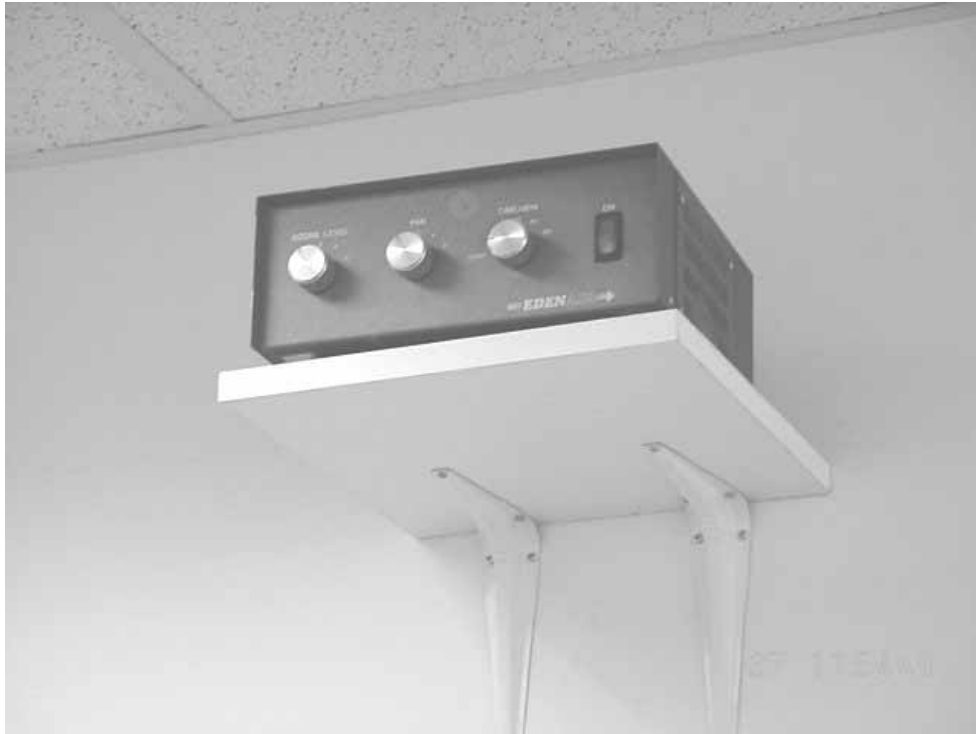
**Picture 9**

A number of other conditions were noted during the assessment, which can affect indoor air quality. Several ozone generating air purifiers were stationed on shelves throughout the building (see Picture 9). At this time, no federal government agency has approved the efficacy of ozone as an indoor air cleaner for use in occupied spaces. While ozone may be effective in removing some odors of biological origin (i.e. skunk odors), its use as a universal air cleaner has come under question (USEPA, 2003). Ozone is a highly irritating substance to the respiratory system. Until more definitive information becomes available, ozone generators in occupied areas should be used with caution. In

**Ozone Generator (One of Six)**

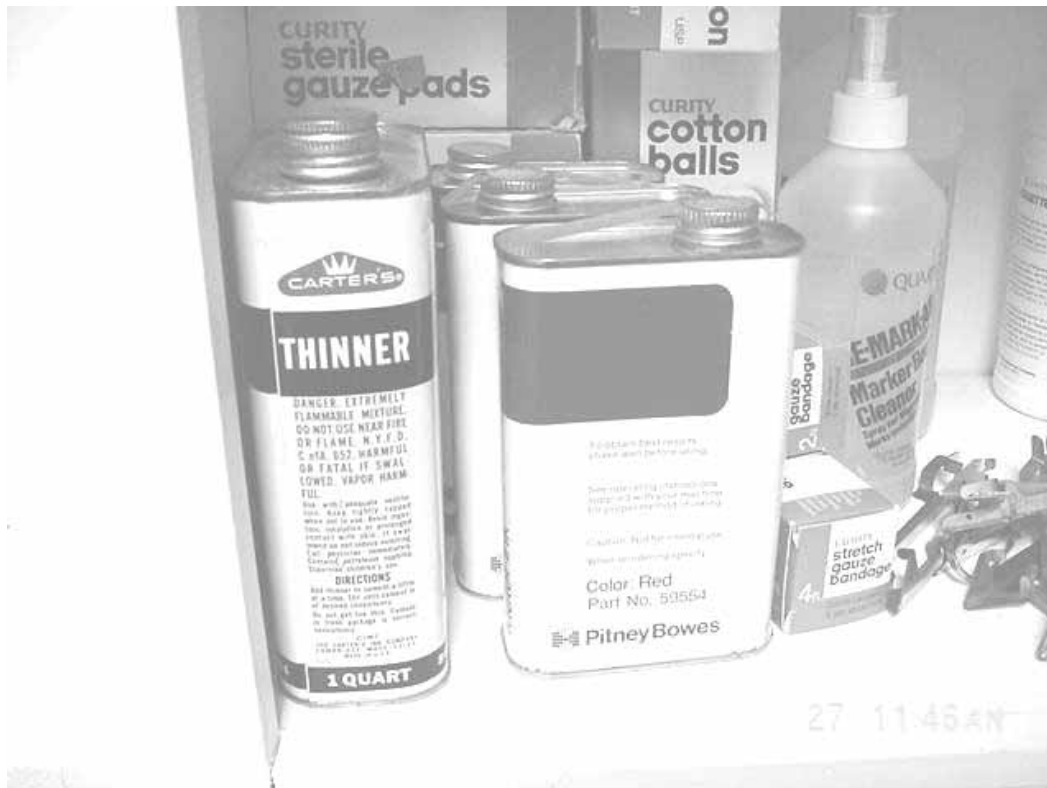
**Picture 10**

A container of paint thinner dated 1967 and other products containing volatile organic compounds (VOCs) were observed on a wooden shelf in the storage room (see Picture 10). VOCs can be irritating to the eyes, nose and throat. Paint thinner is also a flammable material that should be kept in a flammable locker approved by the National Fire Prevention Agency (NFPA, 1996).

**Paint Thinner (dated 1967) and other VOC-Containing Materials on Wooden Shelf in Storage Room**

15. Relocate or place tile or rubber matting underneath water coolers in carpeted areas.
16. Discard hazardous materials (paint thinner) or empty containers of hazardous materials in a manner consistent with environmental statutes and regulations. Follow proper procedures for storing and securing hazardous materials. Obtain Material Safety Data Sheets (MSDS') for chemicals from manufacturers or suppliers.

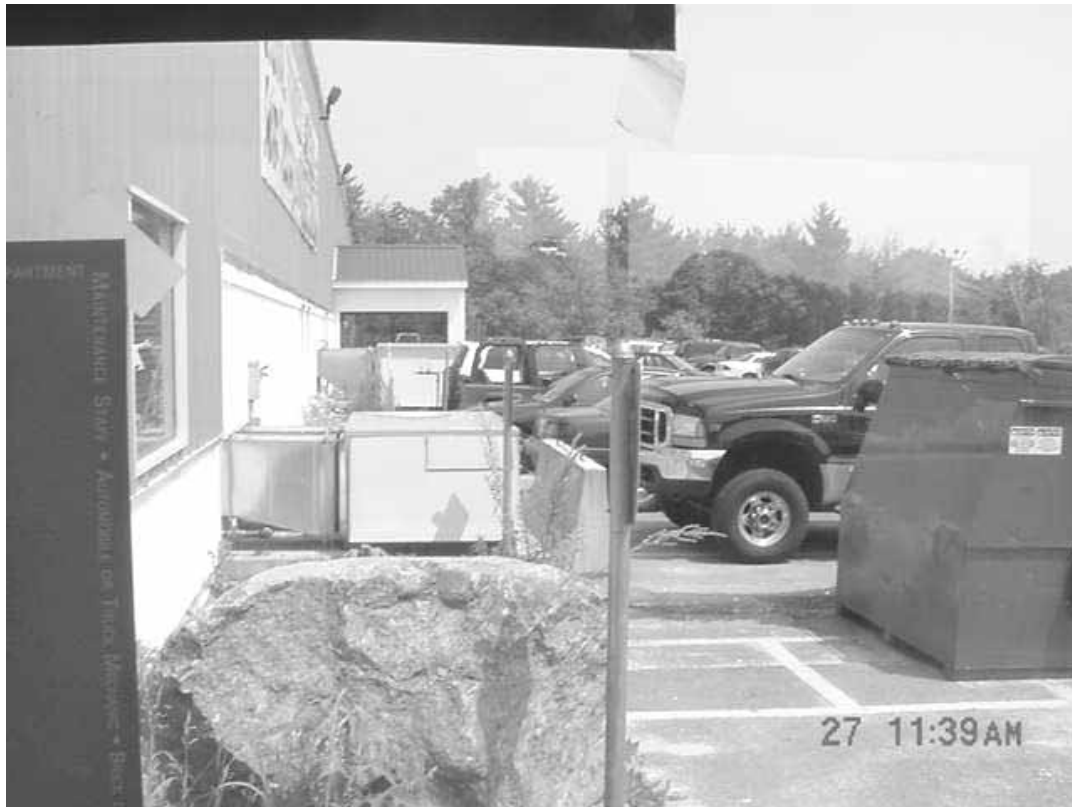
**Picture 11**

Finally, the dumpster is located at the front of the building in close proximity to one of the AHUs. Although no reports of trash odors were reported, the close proximity of the dumpster to the building may provide for nuisance odors to be entrained through

the AHU fresh air intake (see Picture 12). Another potential source of odor entrainment is vehicle exhaust. Picture 12 also shows vehicles parked in close proximity to the AHU. Idling vehicles can result in the entrainment of vehicle exhaust into the building, which may, in turn, provide opportunities for exposure to compounds such as carbon monoxide. M.G.L. chapter 90 section 16A prohibits the unnecessary operation of the engine of a motor vehicle for a foreseeable time in excess of five minutes (MGL, 1996).

**Front View of 215 Hamilton Street Illustrating the Proximity of The Dumpster and Parked Vehicles to the AHU, Note Second Car in is Backed into its Spot**

- area with a HEPA filtered vacuum cleaner to clean up all residual dirt, dust and particulates.
22. Consider relocating the dumpster away from the AHU as a means to minimizing/preventing odor entrainment.
  23. Consider prohibiting parking in the general areas of the AHU to minimize/prevent vehicle exhaust entrainment. If not, feasible consider posting signs instructing occupants/visitors not to back into parking spots.
  24. For further building-wide evaluations and advice on maintaining public buildings, see the resource manual and other related indoor air quality documents located on the MDPH's website at <http://www.state.ma.us/dph/beha/iaq/iaqhome.htm>.
